# Understanding VIP CPU Running at 99% and Rx-Side Buffering

Document ID: 12810

This document explains why the Versatile Interface Processor (VIP) CPU runs at 99%, and what are Rx-side buffers.

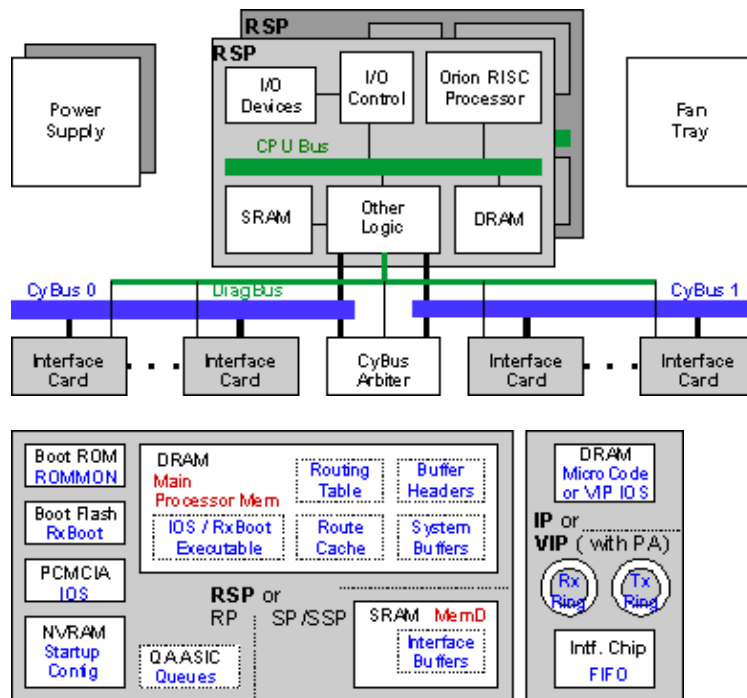
**Figure 1 Cisco 7500 Series Architecture**

Each interface processor (legacy IP or VIP) has one connection to a high-speed extended system bus called a CyBus. Route/Switch Processors (RSPs) are connected to two CyBuses (see Figure 1).
